STS-103 FLIGHT READINESS REVIEW

Presenter:
	Organization/Date: Orbiter/11-19-99

November 19, 1999

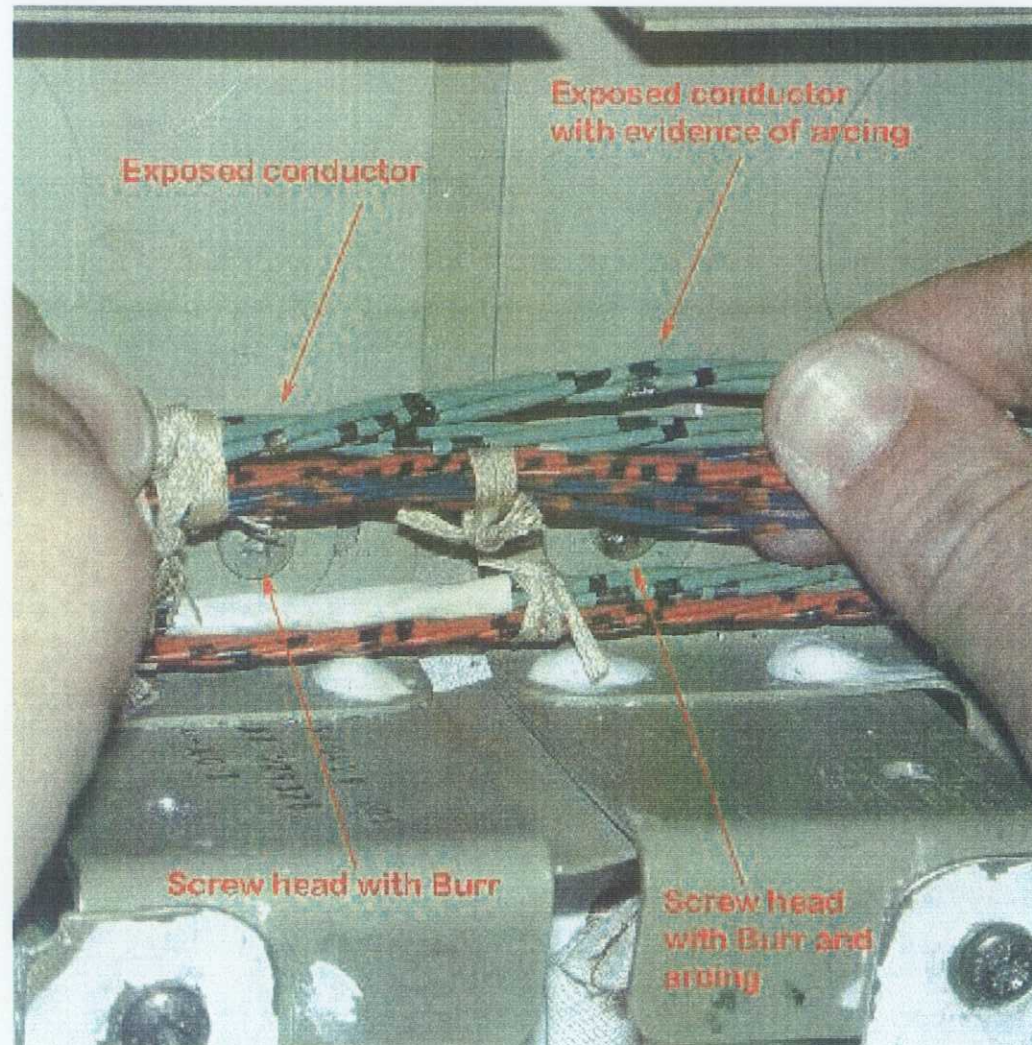
- STS-93 AC1 short was isolated to a mechanically induced exposed conductor located above a rough screw head in the lower port midbody wire tray between bays 11 and 12
  - The exposed conductor had shorted to the screw head
- During the initial inspections of OV-102 and OV-104, additional wire damage was found

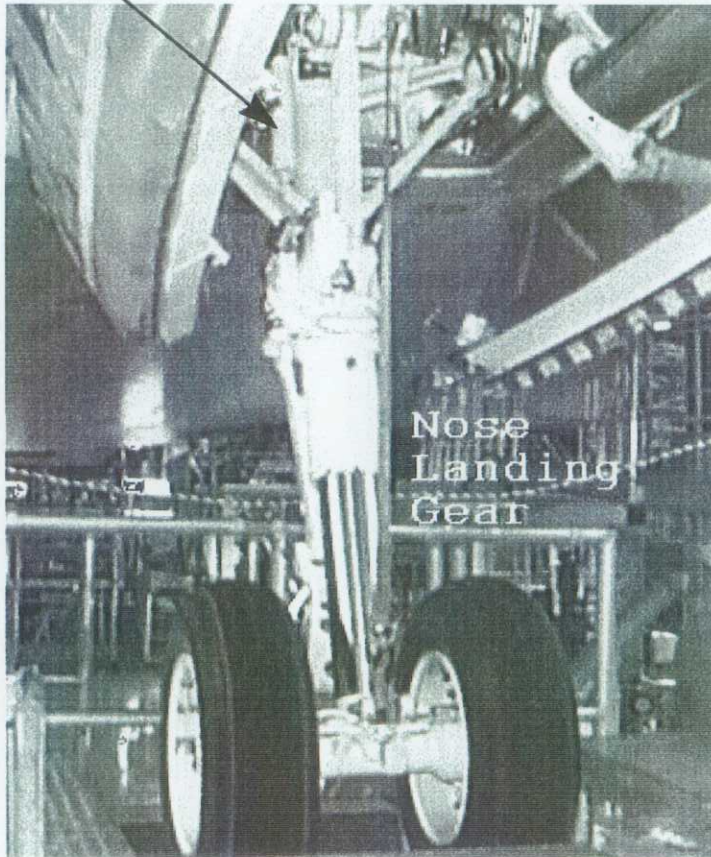
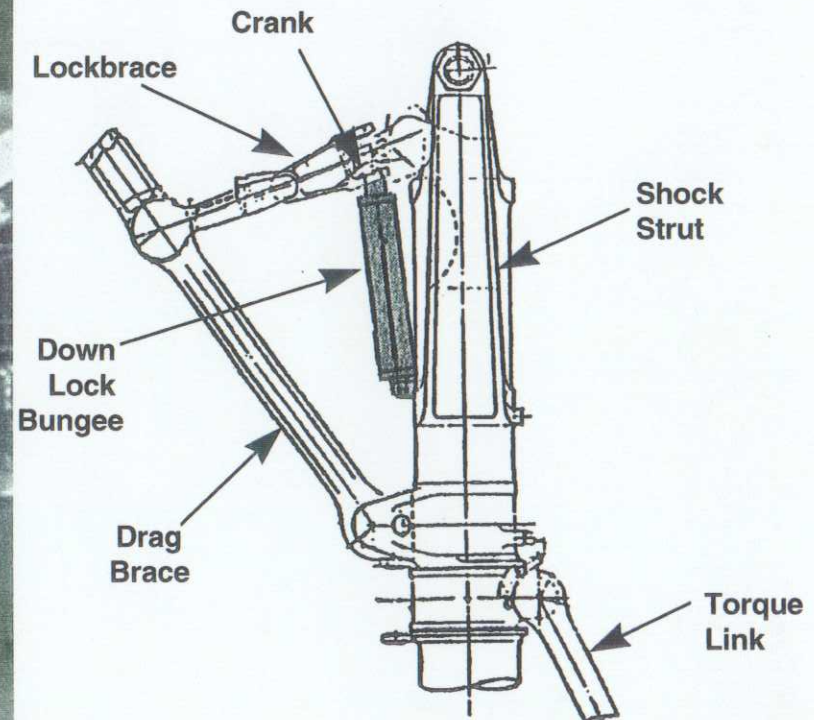
Down Lock  
Bungee

- OV-101 Nose Landing Gear (NLG) lockbrace bungee crank failed near upper attach fitting during gear cycle 2424 of certification extension test series
- During bungee crank investigation, bungee assy found to be not per print and damaged

- Bungee failure analysis indicates that dry film wear on spring and housing and over size spring caused higher load output
- Successful inspection of bungee system weak links verified overload condition is not present
  - NLG bell crank eddy current
  - MLG lower attachment cross bolt hole measurement
- Final gear functional in OPF demonstrated proper operation

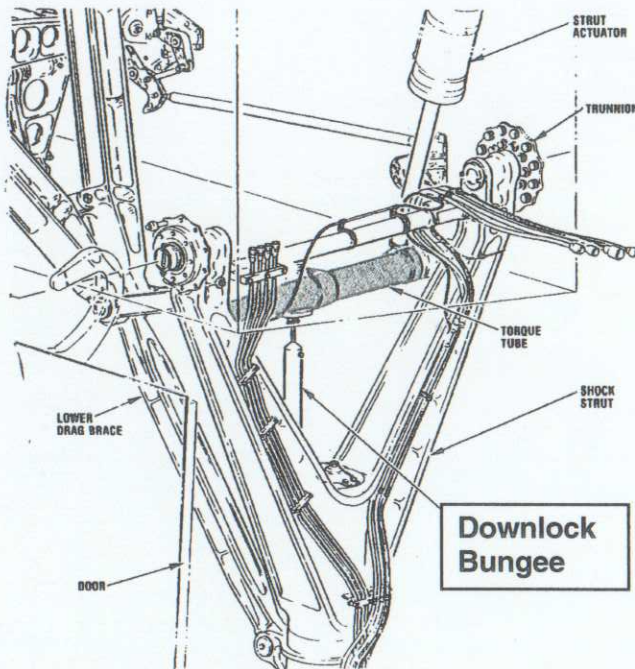
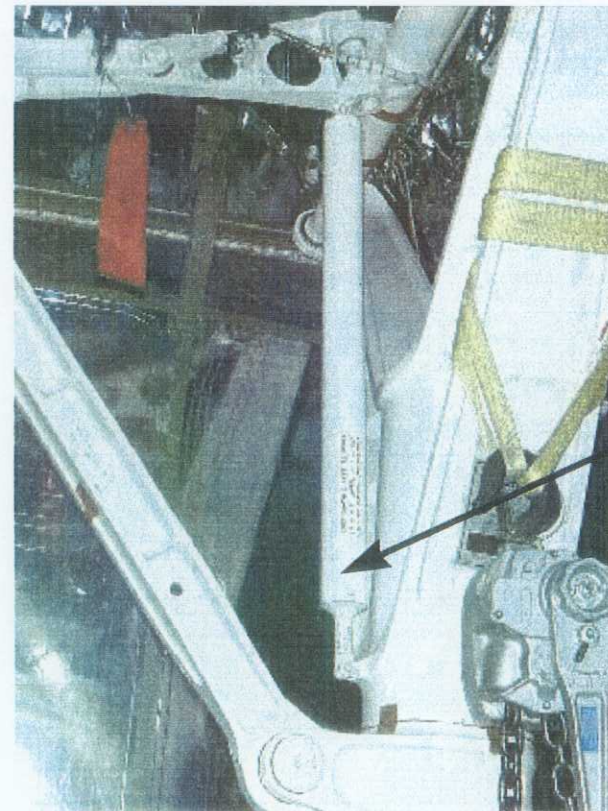
## MLG Downlock Bungee

- Main gear bungee similar clearance, longer stroke, maximum operating load = 578 lb
- Evaluated main gear system capability to tolerate friction

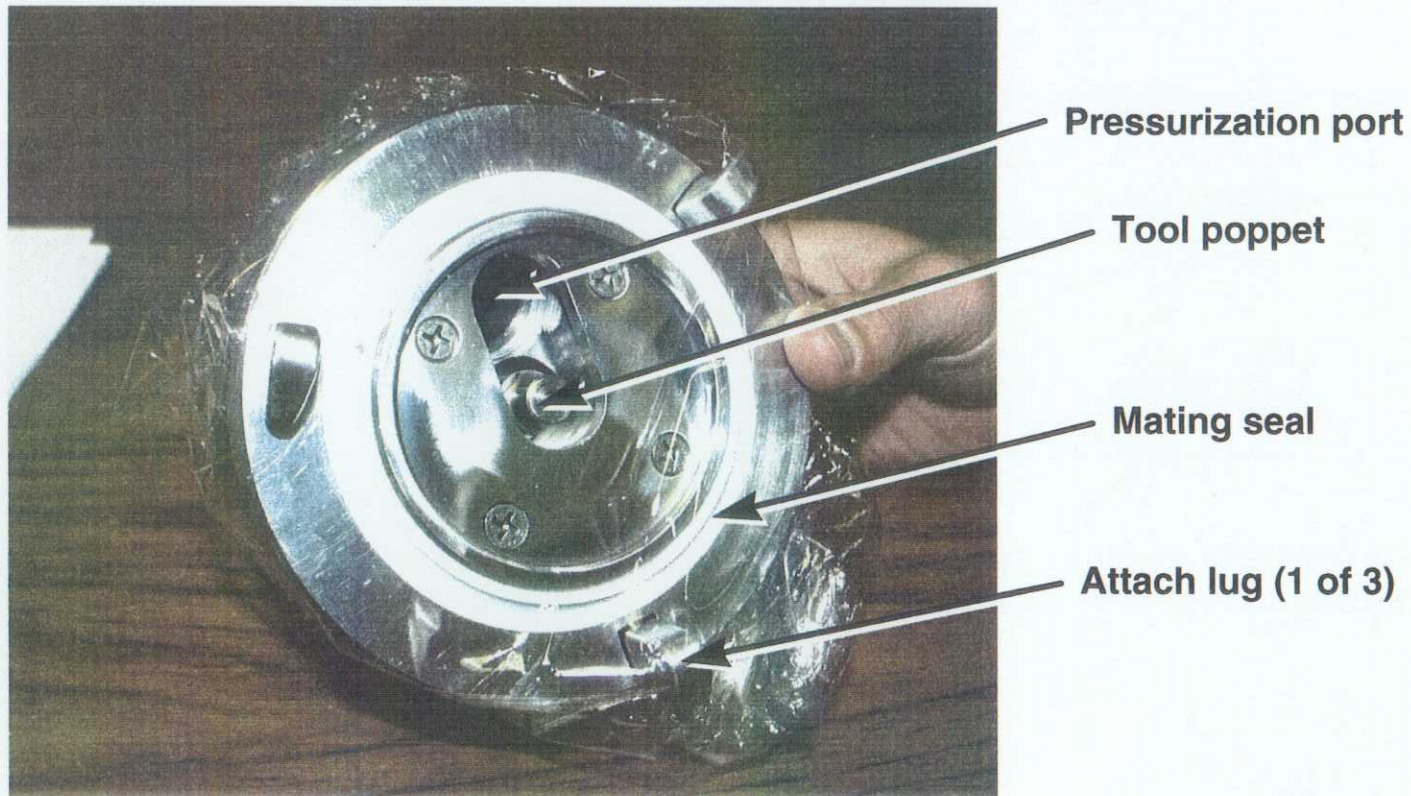
- Pressurization of ET LO2 tank is accomplished via a GSE tool attached to the GO2 2 inch disconnect
